# Manhole Inspection Summary

Manhole # S23YY1007MH

**Location** Address: **7 MERRYMOUNT RD**

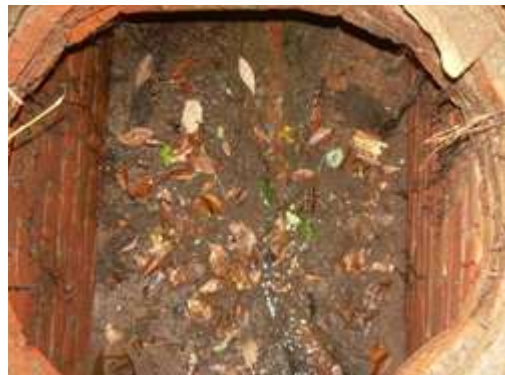
Top View

Adjustment deterioration, root intrusion and infiltration. Channel debris.

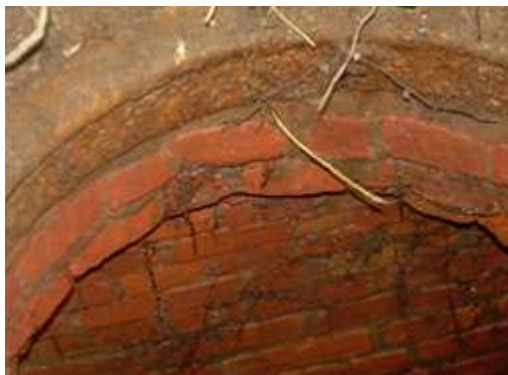
Defect

Frame leaks. Adjustment, Corbel and Barrel root intrusion and infiltration.

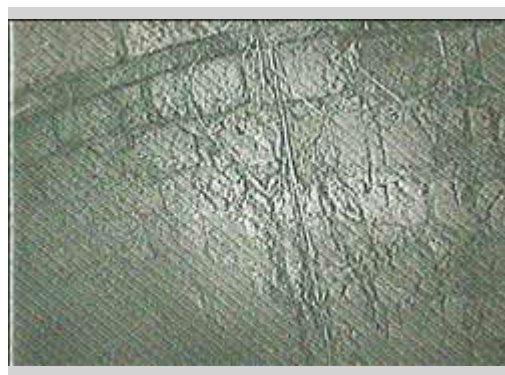
Defect

Barrel deterioration, root intrusion and infiltration.

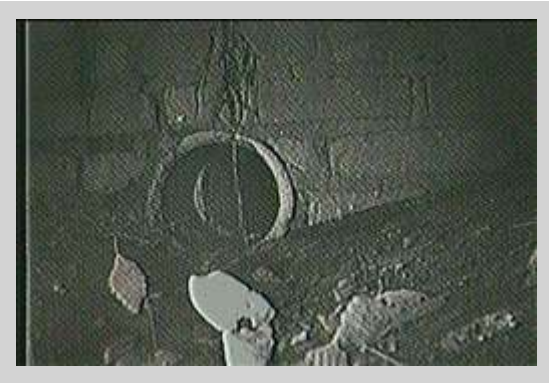
### 6 in. Circular Gravity Sewer Pipe Out @ 12 O'Clock

Barrel deterioration, root intrusion and infiltration.

Infiltration: **Evidence** Pipe Seal Cond: **Cracked**

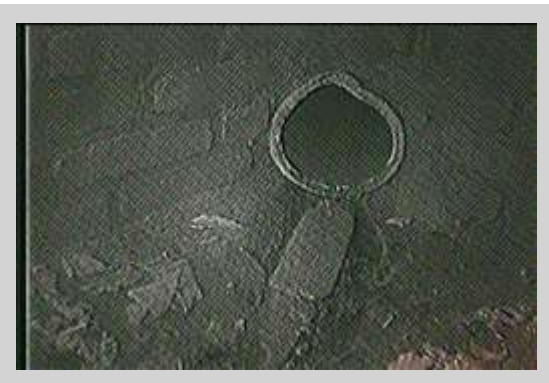
### 6 in. Circular Gravity Sewer Pipe In @ 4 O'Clock

Infiltration: **Evidence** Pipe Seal Cond: **Cracked**
